Home Inspection Report

Inspection Address: 288 Sunny Way

Inspector: Joe Gardino

Inspection Date: 9/15/2022

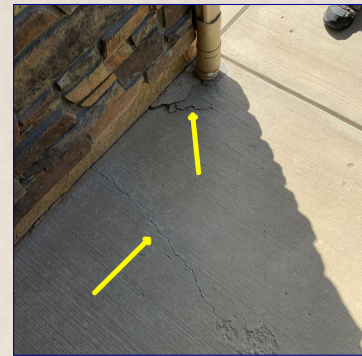
The Service Walk View

There is spalling on the service walks. Spalling is a common surface imperfection. In most cases, the defect does not affect the slab's service life if untreated. Recommend a professional contractor repair to help prevent additional damage as needed.

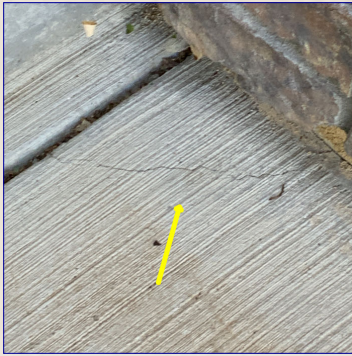
The walkway had some typical cracking/chipping but is usable. Recommend a professional contractor seal the cracks to help prevent additional damage.

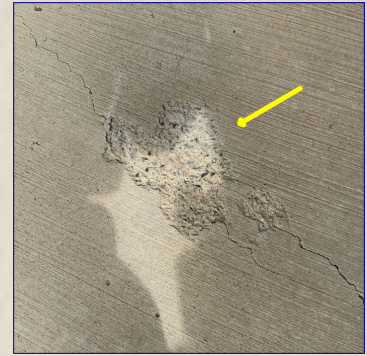
The Service Walk View

There is spalling on the service walks. Spalling is a common surface imperfection. In most cases, the defect does not affect the slab's service life if untreated. Recommend a professional contractor repair to help prevent additional damage as needed.

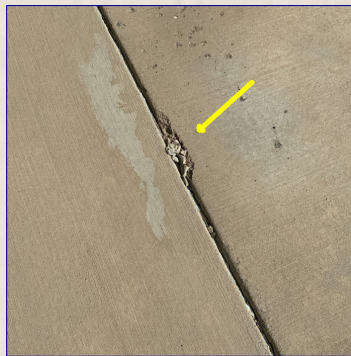
The Driveway View

The driveway has areas of spalling. Spalling is a common surface imperfection. In most cases, the defect does not affect the slab's service life if untreated. Recommend a professional contractor repair to help prevent additional damage.

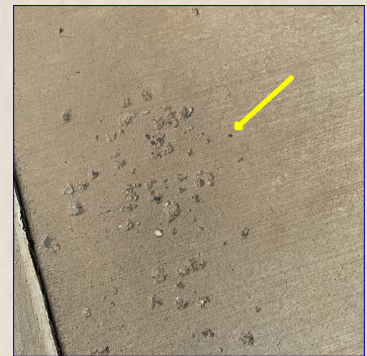
The driveway has areas of spalling. Spalling is a common surface imperfection. In most cases, the defect does not affect the slab's service life if untreated. Recommend a professional contractor repair to help prevent additional damage.

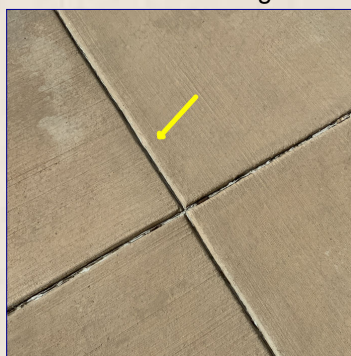
The driveway is cracked. Recommend sealing the cracks to help prevent additional damage. Consult a professional contractor as needed.

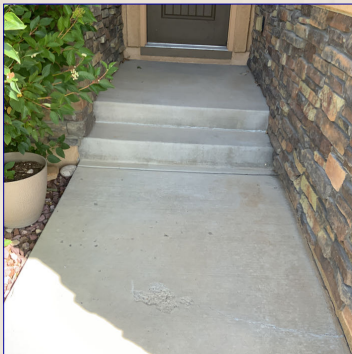
The Steps/Stoop View

There is a crack at the steps. Recommend a professional contractor seal the crack to help prevent additional damage to the concrete.

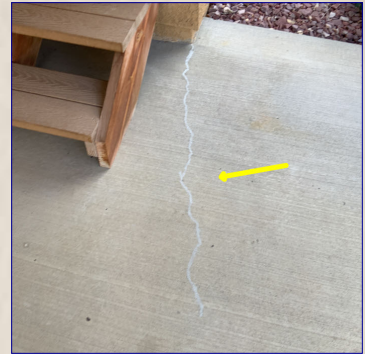
The patio has typical cracks. Recommend a professional contractor seal the cracks to help protect the cement from damage.

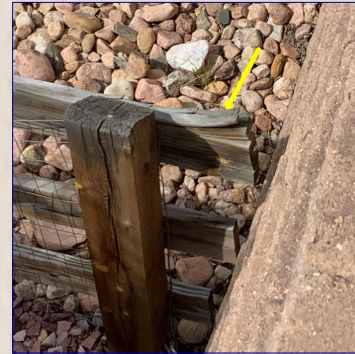
The Fence View

The fence has some damage. Recommend monitoring and consulting with a professional contractor for regular maintenance repairs as needed.

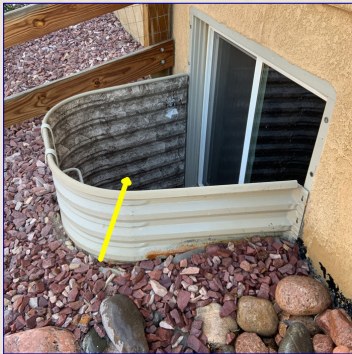
Window well covers are missing in one or more locations. Adding window well covers will help prevent moisture and debris from entering the window wells. In addition, an open window well is a falling hazard. Recommend adding window well covers.

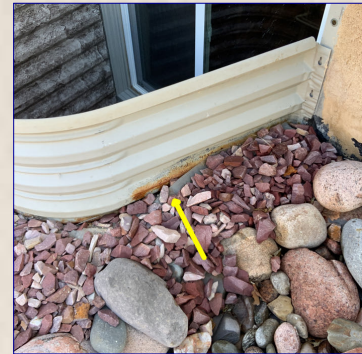
The window well had some rusting. Recommend monitoring and contacting a licensed contractor as needed.

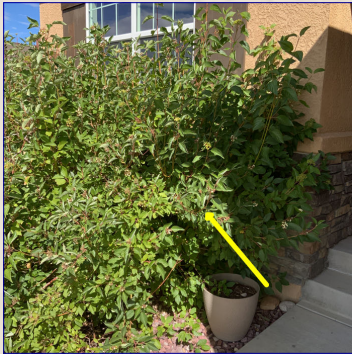
There is vegetation in contact with the house. Recommend trimming trees/vegetation, so it doesn't come into contact with the home.

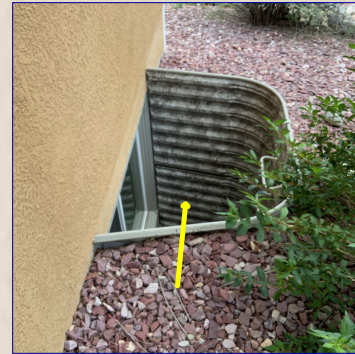
Window well covers are missing in one or more locations. Adding window well covers will help prevent moisture and debris from entering the window wells. In addition, an open window well is a falling hazard. Recommend adding window well covers.

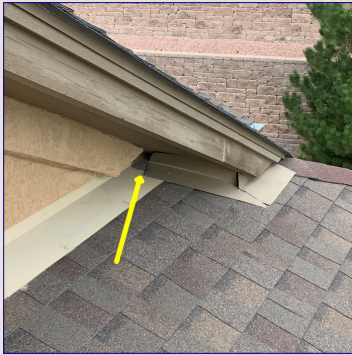
There were gaps at the flashing. Recommend a licensed roofer evaluate repair as needed.

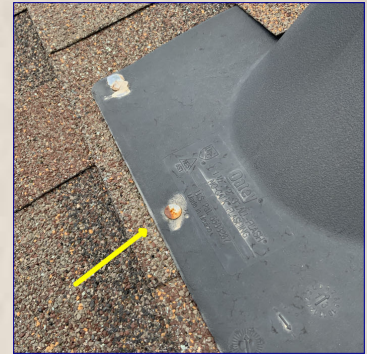
There are exposed nail heads securing the flashing to the roof. Exposed nail heads can allow water to penetrate the roof. Recommend a licensed roofer to seal the nail heads.

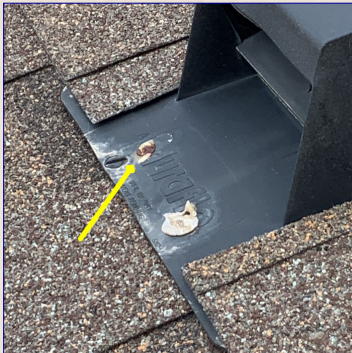
There are exposed nail heads securing the flashing to the roof. Exposed nail heads can allow water to penetrate the roof. Recommend a licensed roofer to seal the nail heads.

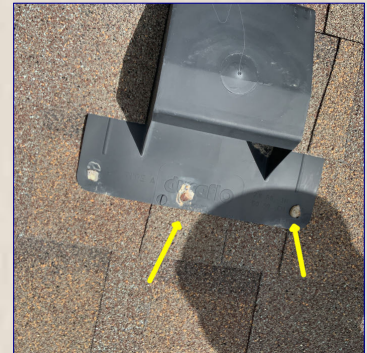
There are exposed nail heads securing the flashing to the roof. Exposed nail heads can allow water to penetrate the roof. Recommend a licensed roofer to seal the nail heads.

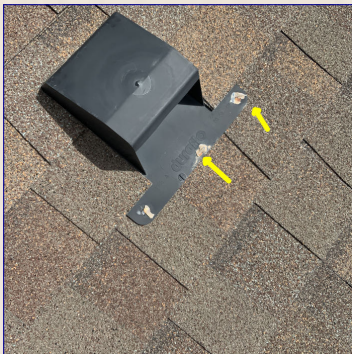
There are exposed nail heads securing the flashing to the roof. Exposed nail heads can allow water to penetrate the roof. Recommend a licensed roofer to seal the nail heads.

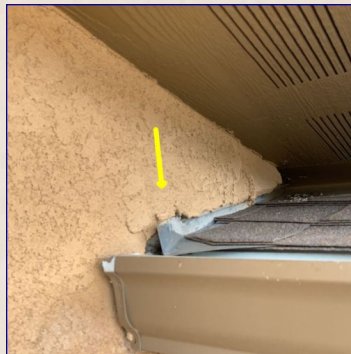
Kick Out flashing is missing at one or more locations, which may allow moisture damage on the home's exterior, walkways, and driveways. Recommend a licensed contractor install flashing to help properly move water to the gutter system. Repair damaged areas as needed.

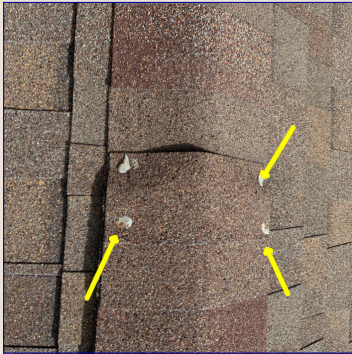
There are exposed nail heads on the roof. Exposed nail heads may allow water to seep through and damage the sheathing over time. Recommend a licensed roofer caulk the exposed nail heads.

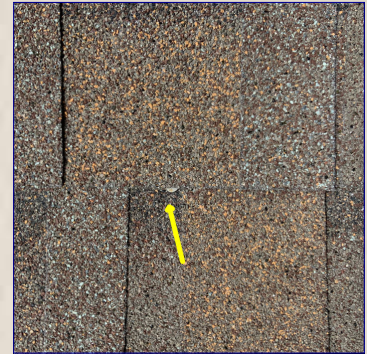
There are exposed nail heads on the roof. Exposed nail heads may allow water to seep through and damage the sheathing over time. Recommend a licensed roofer caulk the exposed nail heads.

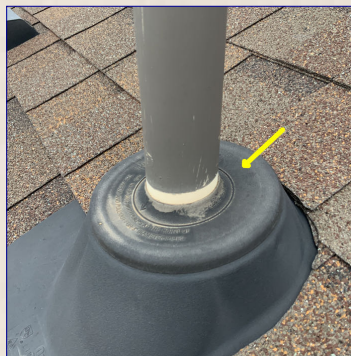
The Plumbing Vent(s)

One or more plumbing vent flashing was sunken, which can allow water/ice build-up and cause premature failure and leaking of the plumbing vent. Recommend a professional roofing contractor repair or replace the roof pipe flashing.

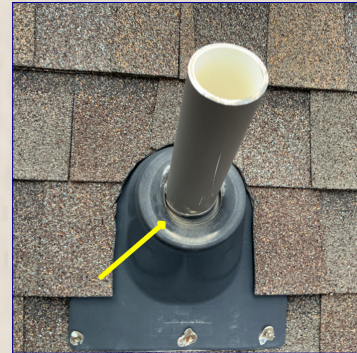
The Plumbing Vent(s)

One or more plumbing vent flashing was sunken, which can allow water/ice build-up and cause premature failure and leaking of the plumbing vent. Recommend a professional roofing contractor repair or replace the roof pipe flashing.

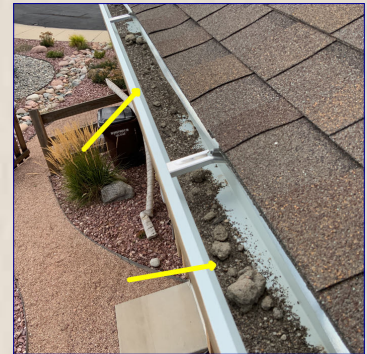
The gutters are dirty. Recommend cleaning the gutters to ensure proper water flow to the downspouts.

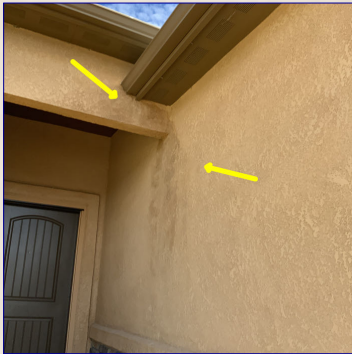
The stucco had moisture staining. Recommend a licensed contractor evaluate and repair as needed.

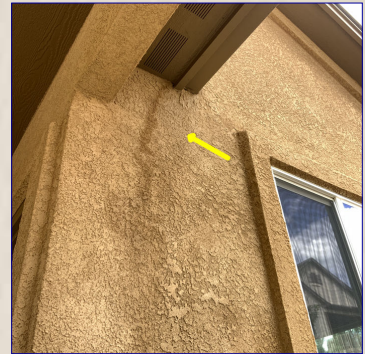
The stucco siding had moisture staining. Recommend a licensed contractor evaluate and repair as needed.

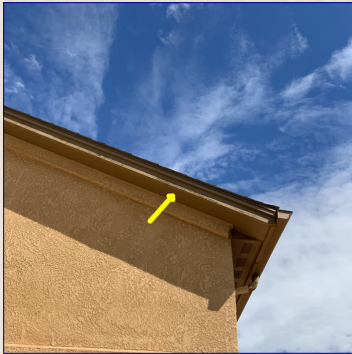
The fascia needs routine painting maintenance. Recommend a professional painter repair/paint the fascia.

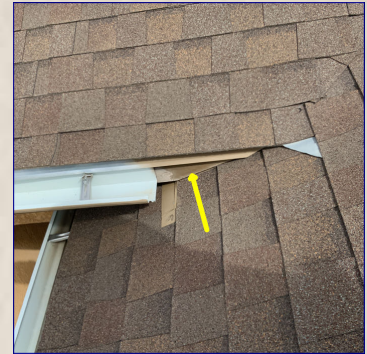
The fascia needs routine painting maintenance. Recommend a professional painter repair/paint the fascia.

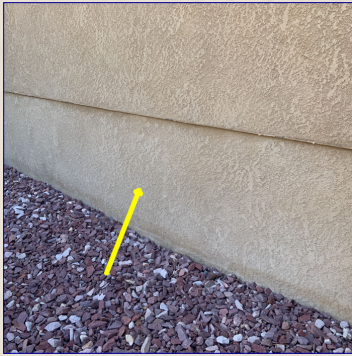
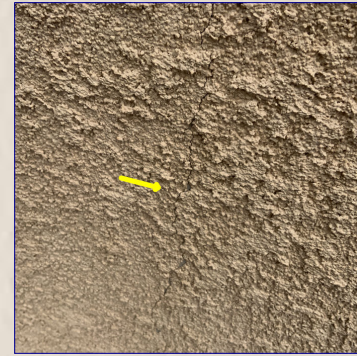
One or more areas of the foundation wall(s) have limited or no visibility due to foundation paint. No evaluation can be made. Recommend monitoring and consulting a licensed contractor as needed.

There are expected vertical cracks in the foundation. All cracks have a potential for leaking and for future potential movement, which can not be predicted. Recommend sealing and monitoring. Consult a licensed foundation expert if any cracks start leaking or become active.

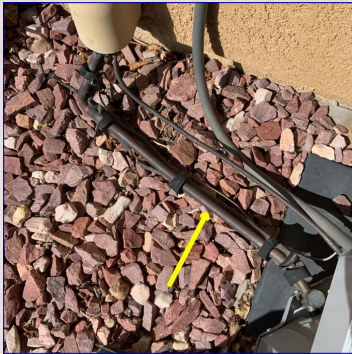
There is damaged and/or missing insulation on the air conditioner refrigerant line. Recommend replacing insulation.

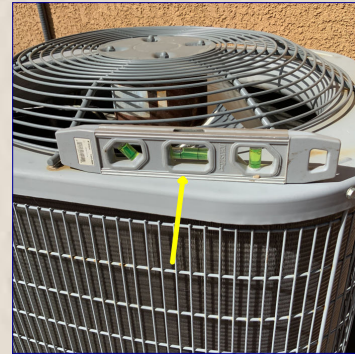
The air conditioner condensing unit is not level. Recommend a professional contractor to re-level the unit.

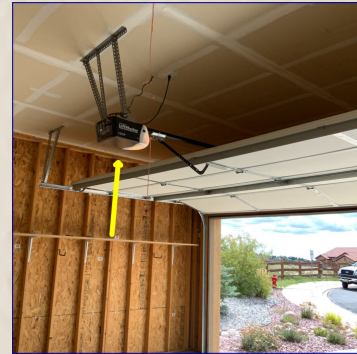
Page 24 Item: 2	Automatic Opener	<ul style="list-style-type: none"> The automatic garage door opener was not working properly. Recommend a professional contractor evaluate and repair or replace as needed.
-----------------	------------------	--

The automatic garage door opener was not working properly. Recommend a professional contractor evaluate and repair or replace as needed.

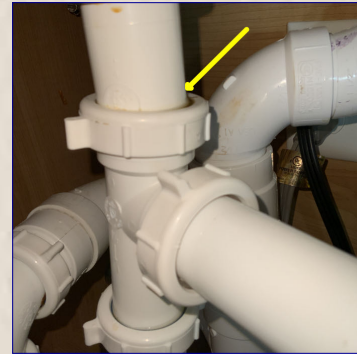
Page 28 Item: 4	Plumbing	<ul style="list-style-type: none"> Drains in the kitchen are leaking, recommend a licensed plumber repair.
-----------------	----------	---

Drains in the kitchen are leaking, recommend a licensed plumber repair.

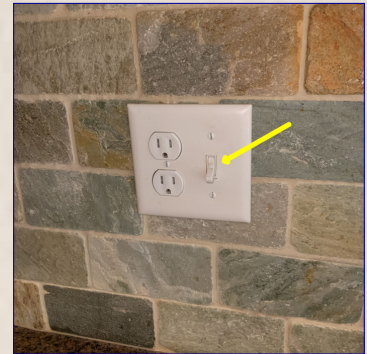
The switch did not appear to operate a fixture. Recommend contacting current owners as to purpose of switch. Contact a licensed electrician as needed.

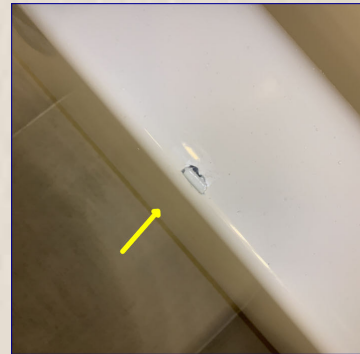
There are chips in the bathtub. Recommend sealing the chips to help prevent additional damage.

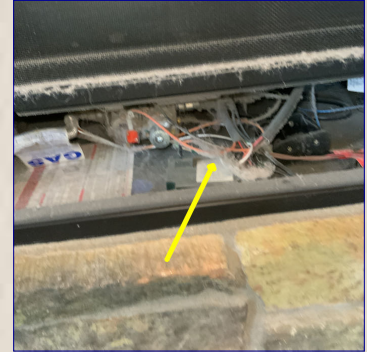
The fireplace compartment was dirty. Recommend cleaning compartment.

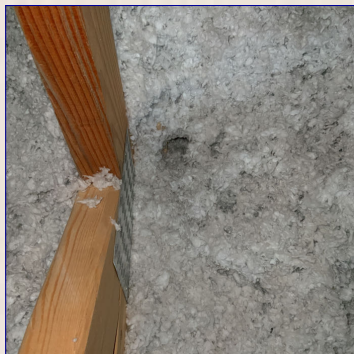
Pests are not part of the home inspection. However, there is evidence of rodents in the attic, which is a safety concern. Recommend a professional exterminator be consulted.

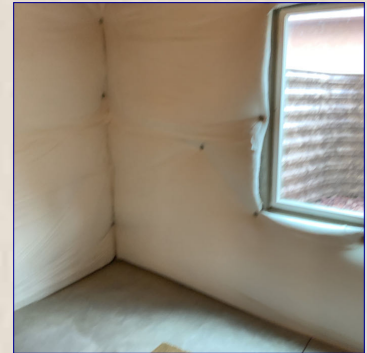
Foundation walls were covered with paneling/drywall/insulation/storage and were not visible. It is always possible that hidden damage may exist in non-visible areas. Consult a licensed contractor as needed.

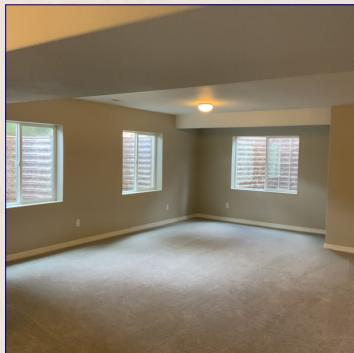
Foundation walls were covered with paneling/drywall/insulation/storage and were not visible. It is always possible that hidden damage may exist in non-visible areas. Consult a licensed contractor as needed.

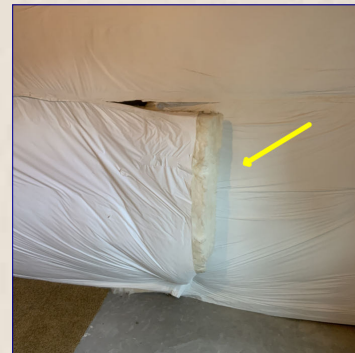
The insulation was displaced. Recommend repair as needed.

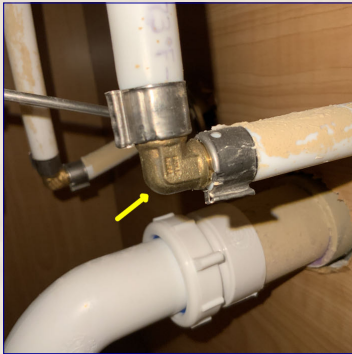
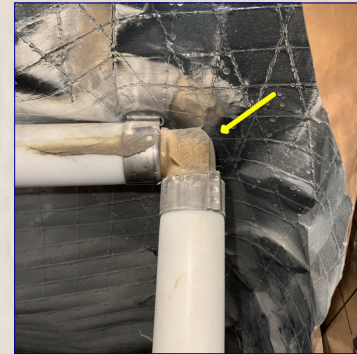
Page 59 Item: 5	Visible Water Distribution Piping	<ul style="list-style-type: none"> Brass fittings were noticed on the PEX house plumbing that appears to be manufactured by Zurn or other manufacturers. These fittings have been known to fail and are part of a class-action lawsuit. The yellow brass fittings can be located at joints in the plastic pipe. Brass fittings are secured to the pipe by copper crimp rings or stainless steel clamps. The fittings were used for a variety of applications, including and without limitation, hot and cold water distribution in plumbing and radiant heating systems in homes, residences, buildings, or other structures. Most manufacturers stopped selling the brass fittings, in question, in 2010. We recommend, however, as part of making an investment decision in this house, that a licensed plumber familiar with the fittings referred to in the class action lawsuit evaluate and repair or replace the fittings as needed.

Brass fittings were noticed on the PEX house plumbing that appears to be manufactured by Zurn or other manufacturers. These fittings have been known to fail and are part of a class-action lawsuit. The yellow brass fittings can be located at joints in the plastic pipe. Brass fittings are secured to the pipe by copper crimp rings or stainless steel clamps. The fittings were used for a variety of applications, including and without limitation, hot and cold water distribution in plumbing and radiant heating systems in homes, residences, buildings, or other structures. Most manufacturers stopped selling the brass fittings, in question, in 2010. We recommend, however, as part of making an investment decision in this house, that a licensed plumber familiar with the fittings referred to in the class action lawsuit evaluate and repair or replace the fittings as needed.

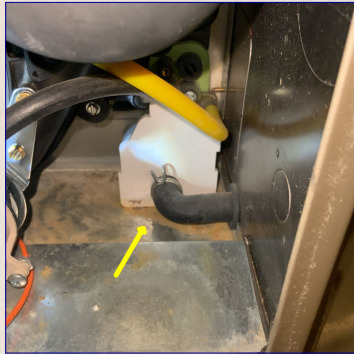
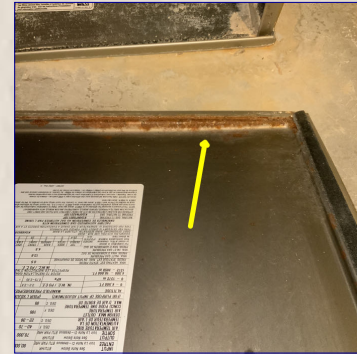
The furnace showed signs of rust and corrosion. Recommend a professional HVAC technician evaluate and repair as needed.
