Home Inspection Report

Inspection Address: 288 Sunny Way

Inspector: Chris Kjeldsen

Inspection Date: 2022/9/15

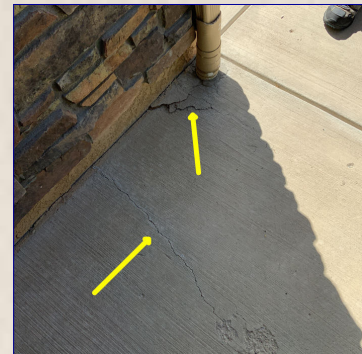
There is spalling on the service walks. Spalling is a common surface imperfection. In most cases, the defect does not affect the slab's service life if untreated. Recommend a professional contractor repair to help prevent additional damage as needed.

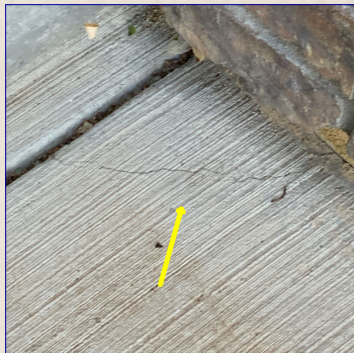
The walkway had some typical cracking/chipping but is usable. Recommend a professional contractor seal the cracks to help prevent additional damage.

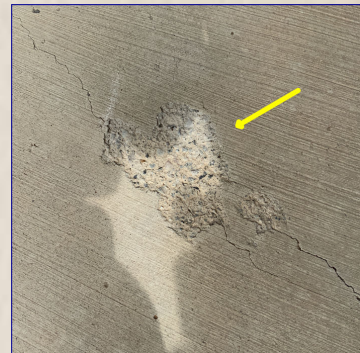
There is spalling on the service walks. Spalling is a common surface imperfection. In most cases, the defect does not affect the slab's service life if untreated. Recommend a professional contractor repair to help prevent additional damage as needed.

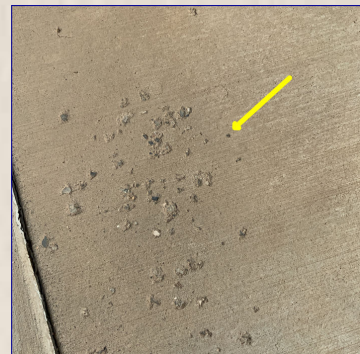
The driveway has areas of spalling. Spalling is a common surface imperfection. In most cases, the defect does not affect the slab's service life if untreated. Recommend a professional contractor repair to help prevent additional damage.

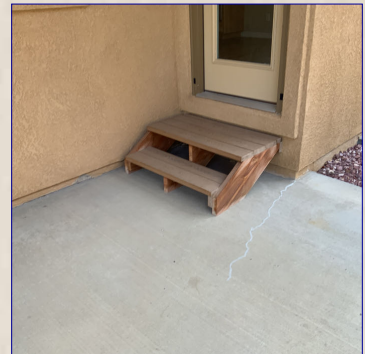
There are open risers on the exterior wood stairs, which is a potential safety concern. Recommend using additional caution in these areas. Install proper risers for added safety.

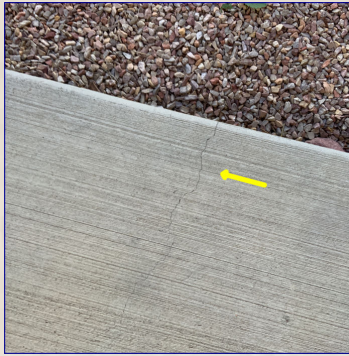
The patio has typical cracks. Recommend a professional contractor seal the cracks to help protect the cement from damage.

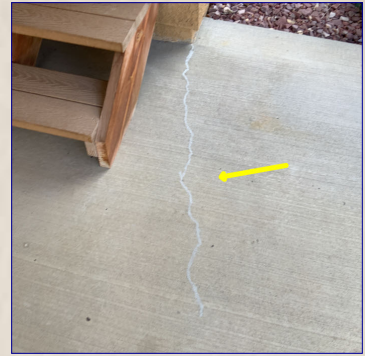
The patio has typical cracks. Recommend a professional contractor seal the cracks to help protect the cement from damage.

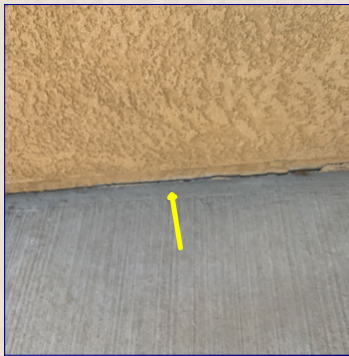
There is a gap between the patio and the house. Recommend sealing the gap between the patio and the house to help prevent water penetration.

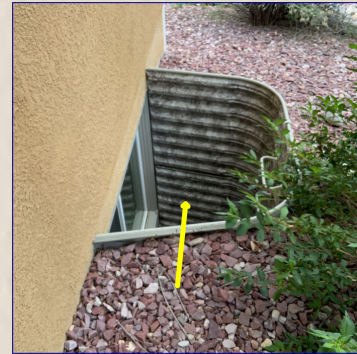
Window well covers are missing in one or more locations. Adding window well covers will help prevent moisture and debris from entering the window wells. In addition, an open window well is a falling hazard. Recommend adding window well covers.

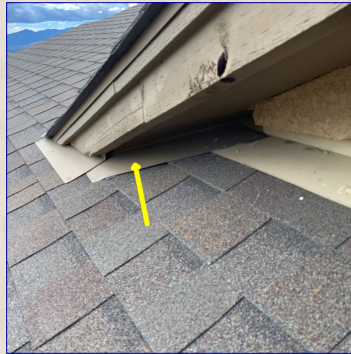
There were gaps at the flashing. Recommend a licensed roofer evaluate repair as needed.

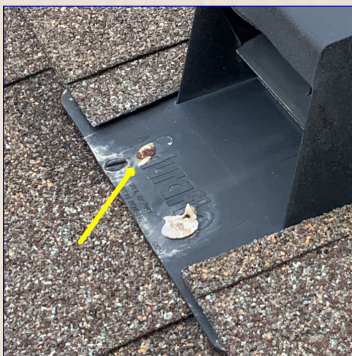
There are exposed nail heads securing the flashing to the roof. Exposed nail heads can allow water to penetrate the roof. Recommend a licensed roofer to seal the nail heads.

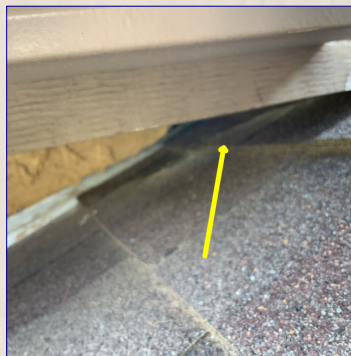
There were areas of missing flashing. Recommend a licensed roofer install flashing.

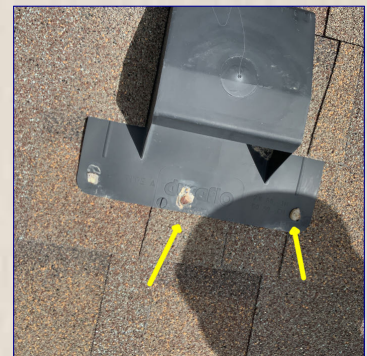
There are exposed nail heads securing the flashing to the roof. Exposed nail heads can allow water to penetrate the roof. Recommend a licensed roofer to seal the nail heads.

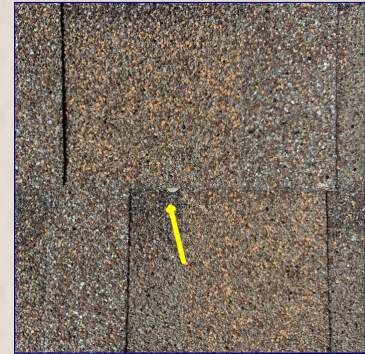
There are exposed nail heads on the roof. Exposed nail heads may allow water to seep through and damage the sheathing over time. Recommend a licensed roofer caulk the exposed nail heads.

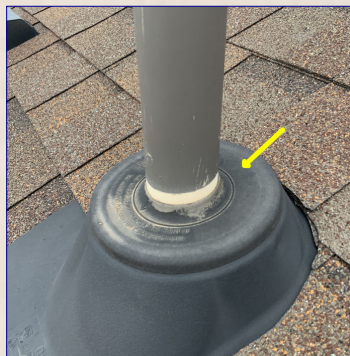
One or more plumbing vent flashing was sunken, which can allow water/ice build-up and cause premature failure and leaking of the plumbing vent. Recommend a professional roofing contractor repair or replace the roof pipe flashing.

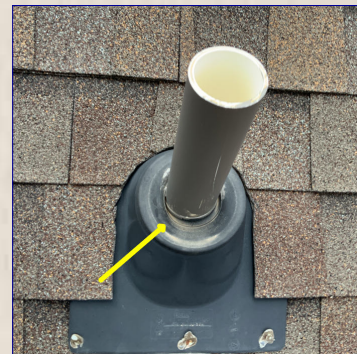
One or more plumbing vent flashing was sunken, which can allow water/ice build-up and cause premature failure and leaking of the plumbing vent. Recommend a professional roofing contractor repair or replace the roof pipe flashing.

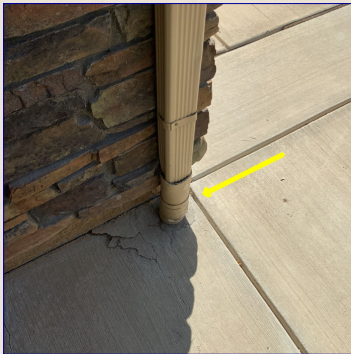
The gutter termination point was not visible. There is always the potential for hidden damage in non visible areas. Recommend monitoring and contacting a licensed contractor as needed.

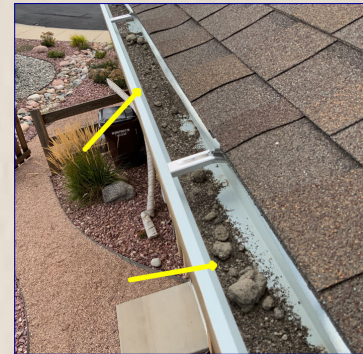
The gutters are dirty. Recommend cleaning the gutters to ensure proper water flow to the downspouts.

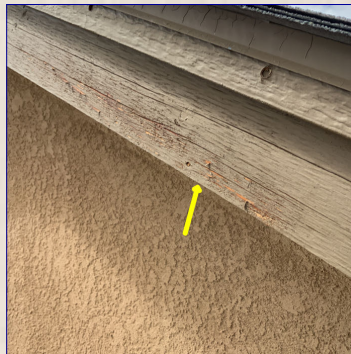
The fascia needs routine painting maintenance. Recommend a professional painter repair/paint the fascia.

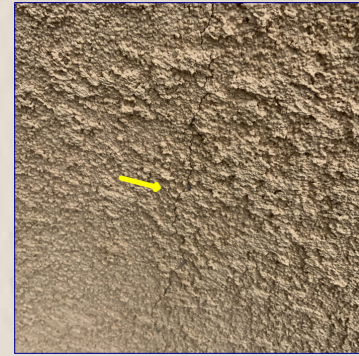
One or more areas of the foundation wall(s) have limited or no visibility due to foundation paint. No evaluation can be made. Recommend monitoring and consulting a licensed contractor as needed.

There are expected vertical cracks in the foundation. All cracks have a potential for leaking and for future potential movement, which can not be predicted. Recommend sealing and monitoring. Consult a licensed foundation expert if any cracks start leaking or become active.

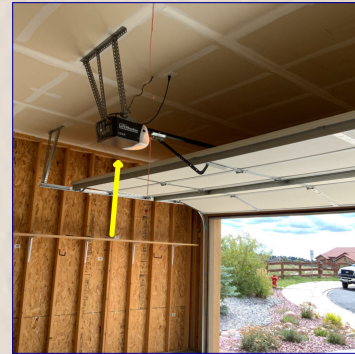
The automatic garage door opener was not working properly. Recommend a professional contractor evaluate and repair or replace as needed.

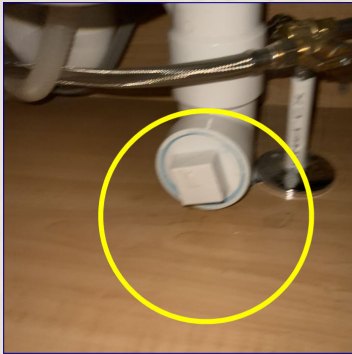
Drains in the kitchen are leaking, recommend a licensed plumber repair.

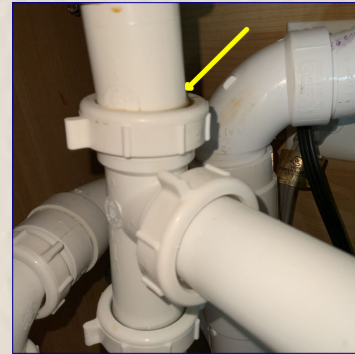
Drains in the kitchen are leaking, recommend a licensed plumber repair.

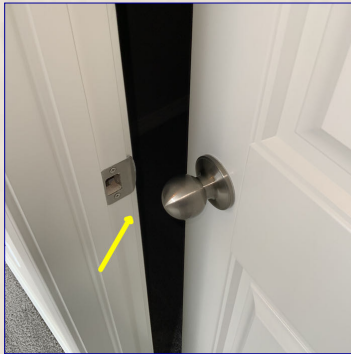
The door does not latch. Recommend repairing as needed.

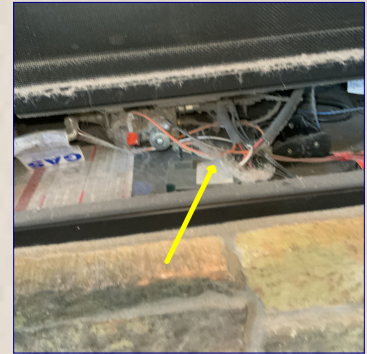
The fireplace compartment was dirty. Recommend cleaning compartment.

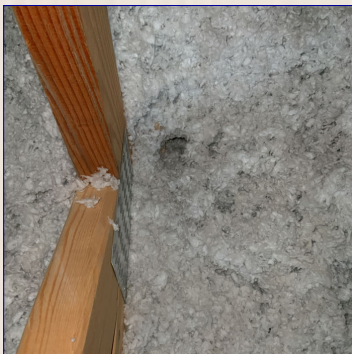
Pests are not part of the home inspection. However, there is evidence of rodents in the attic, which is a safety concern. Recommend a professional exterminator be consulted.

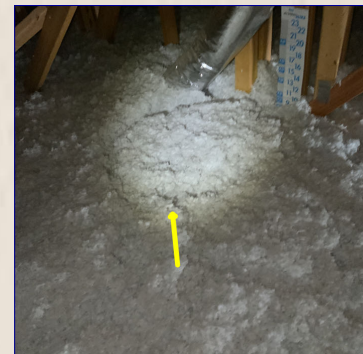
Pests are not part of the home inspection. However, there is evidence of rodents in the attic, which is a safety concern. Recommend a professional exterminator be consulted.

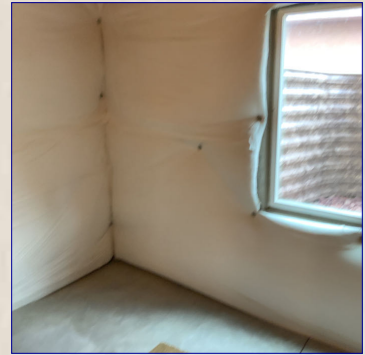
Foundation walls were covered with paneling/drywall/insulation/storage and were not visible. It is always possible that hidden damage may exist in non-visible areas. Consult a licensed contractor as needed.

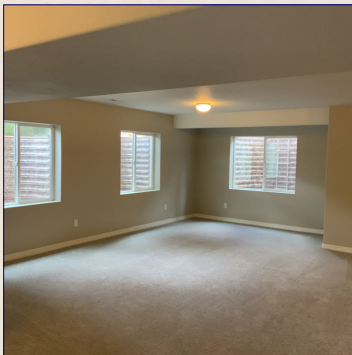
Foundation walls were covered with paneling/drywall/insulation/storage and were not visible. It is always possible that hidden damage may exist in non-visible areas. Consult a licensed contractor as needed.

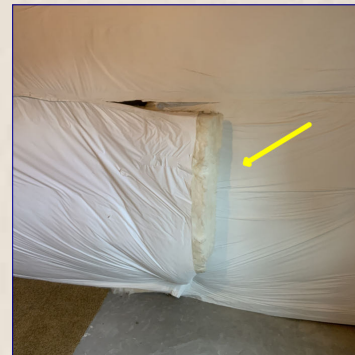
The insulation was displaced. Recommend repair as needed.

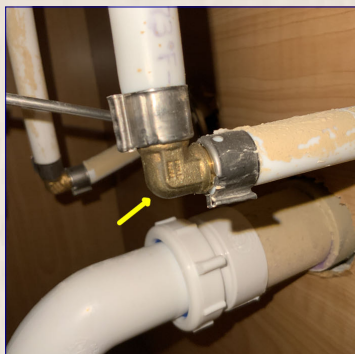
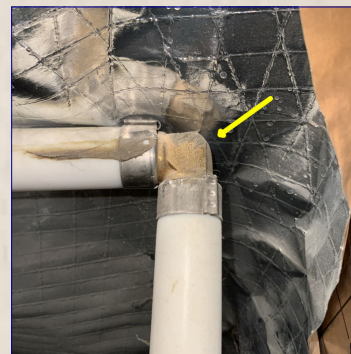
Brass fittings were noticed on the PEX house plumbing that appears to be manufactured by Zurn or other manufacturers. These fittings have been known to fail and are part of a class-action lawsuit. The yellow brass fittings can be located at joints in the plastic pipe. Brass fittings are secured to the pipe by copper crimp rings or stainless steel clamps. The fittings were used for a variety of applications, including and without limitation, hot and cold water distribution in plumbing and radiant heating systems in homes, residences, buildings, or other structures. Most manufacturers stopped selling the brass fittings, in question, in 2010. We recommend, however, as part of making an investment decision in this house, that a licensed plumber familiar with the fittings referred to in the class action lawsuit evaluate and repair or replace the fittings as needed.
