Home Inspection Report

Inspection Address: 288 Sunny Way

Inspector: Joe Gardino

Inspection Date: 9/15/2022

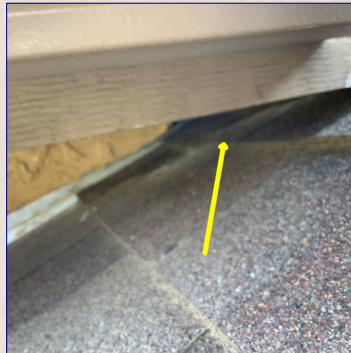
There were areas of missing flashing. Recommend a licensed roofer install flashing.

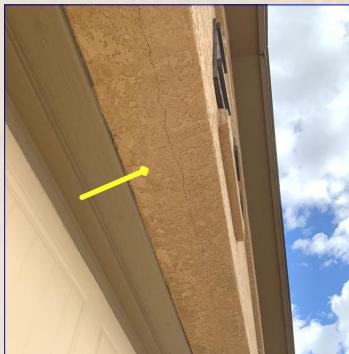
The stucco siding had typical cracking present in one or more areas. Monitor and repair as needed.

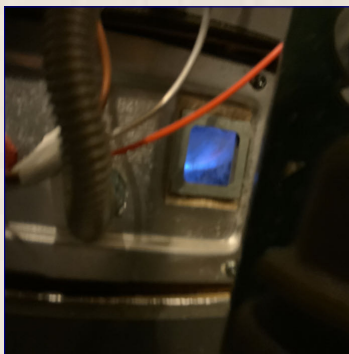
The water heater operating.

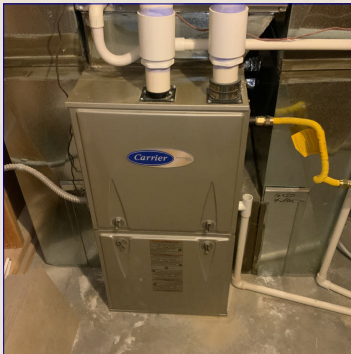
The furnace area

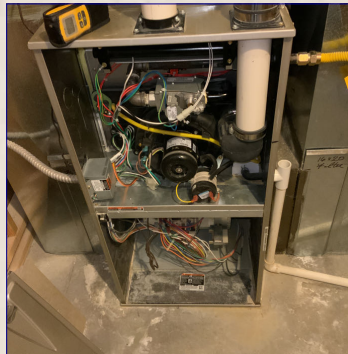
The furnace view, cover off

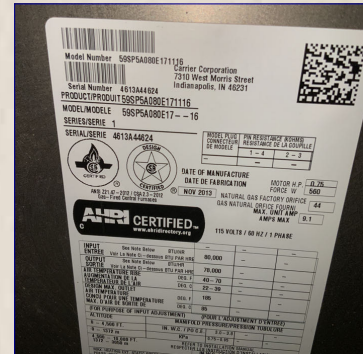
The furnace, data tag

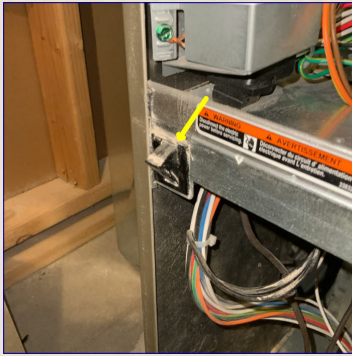
The electrical shutoff switch.

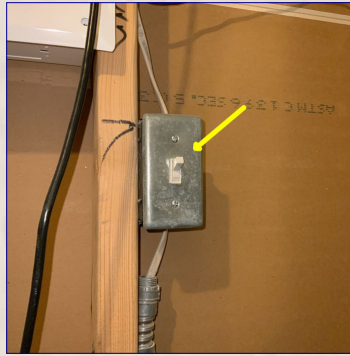
The electrical shutoff switch.

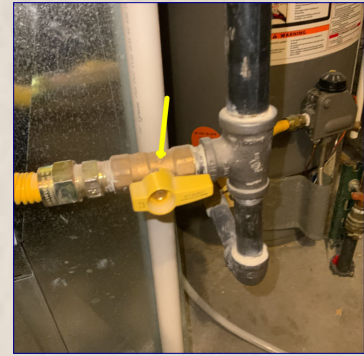
The gas shutoff valve.

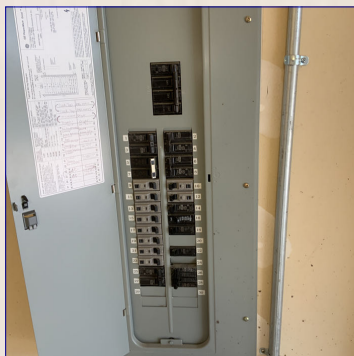
The main electrical service panel.

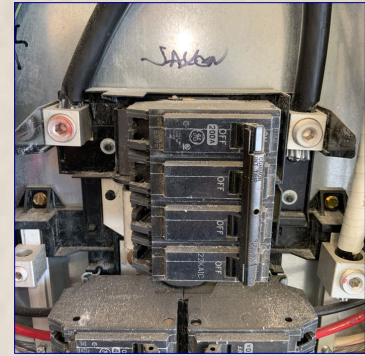
The main electrical service panel shut off breaker.

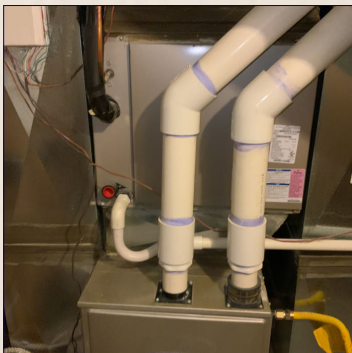
The evaporator coil cabinet.
