Home Inspection Report

Inspection Address: 288 Sunny Way

Inspector: Chris Kjeldsen

Inspection Date: 2022/9/15

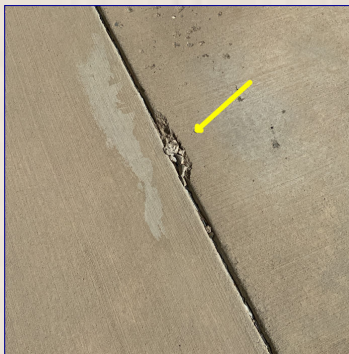
The driveway has areas of spalling. Spalling is a common surface imperfection. In most cases, the defect does not affect the slab's service life if untreated. Recommend a professional contractor repair to help prevent additional damage.

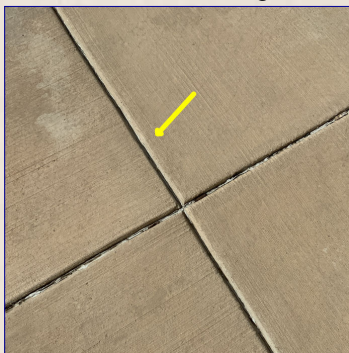
The driveway is cracked. Recommend sealing the cracks to help prevent additional damage. Consult a professional contractor as needed.

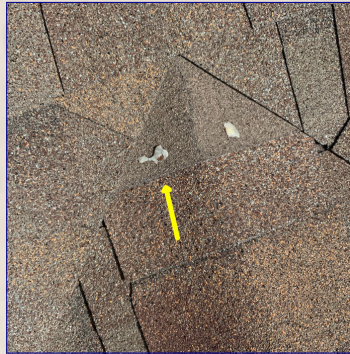
There are exposed nail heads on the roof. Exposed nail heads may allow water to seep through and damage the sheathing over time. Recommend a licensed roofer caulk the exposed nail heads.

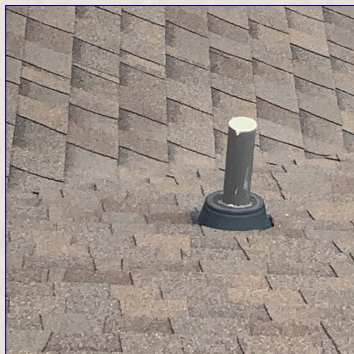
One or more plumbing vent flashing was sunken, which can allow water/ice build-up and cause premature failure and leaking of the plumbing vent. Recommend a professional roofing contractor repair or replace the roof pipe flashing.

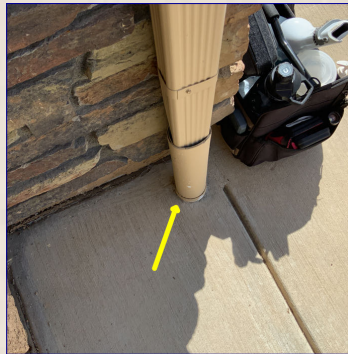
The gutter termination point was not visible. There is always the potential for hidden damage in non visible areas. Recommend monitoring and contacting a licensed contractor as needed.

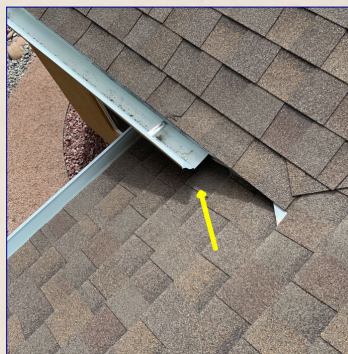
Gutters terminate on roof surfaces, which is a common practice but will concentrate a large amount of water on one location of asphalt shingles. This will allow more wear in one location. Recommend redirecting the water discharge to other gutters or to the ground.

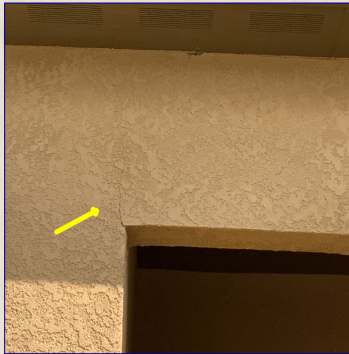
The stucco siding had typical cracking present in one or more areas. Monitor and repair as needed.

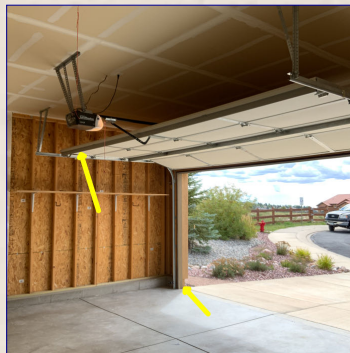
The safety devices on the large garage door cannot be tested due to the door not operating properly. Recommend a licensed contractor repair and re-test safety features on garage door.

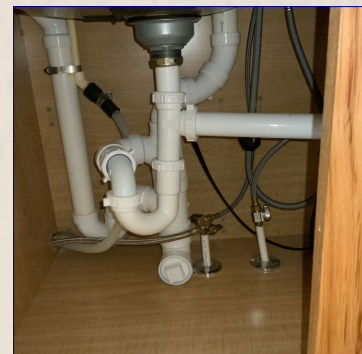
Kitchen plumbing view

Drains in the kitchen are leaking, recommend a licensed plumber repair.

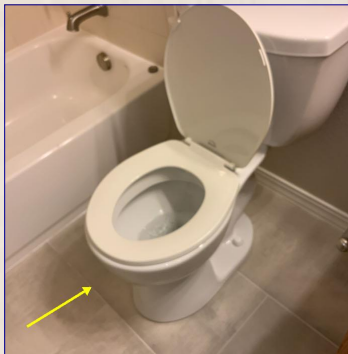
The toilet bowl is loose. Since movement of the toilet will damage the wax ring, recommend replacing the wax ring. While the toilet is removed verify the subfloor is still in good condition. Repair as needed.

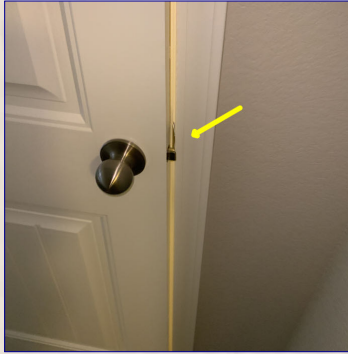
The door does not latch. Recommend repairing as needed.

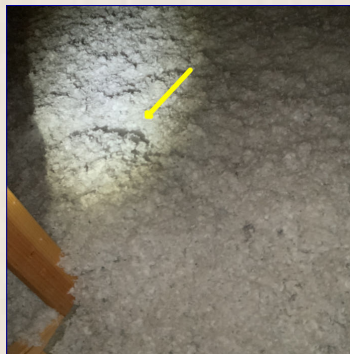
Pests are not part of the home inspection. However, there is evidence of rodents in the attic, which is a safety concern. Recommend a professional exterminator be consulted.

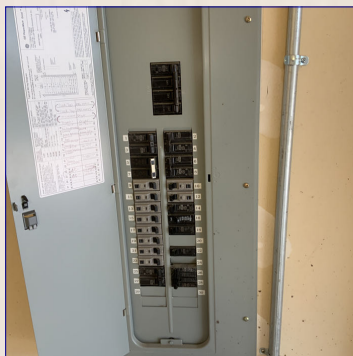
The main electrical service panel.

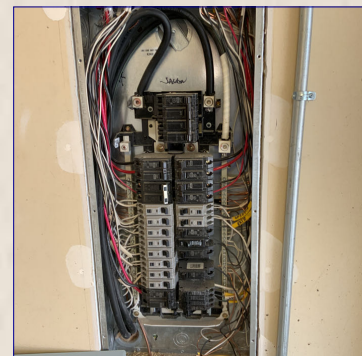
The main electrical service panel-cover removed.

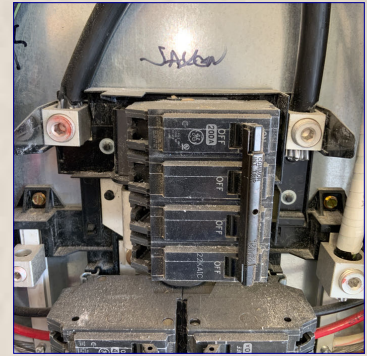
The main electrical service panel shut off breaker.

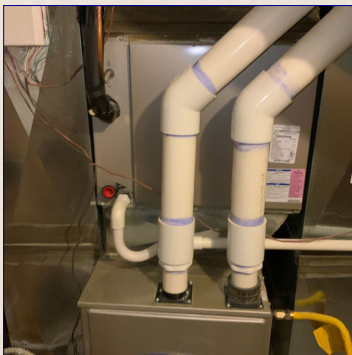
The evaporator coil cabinet.

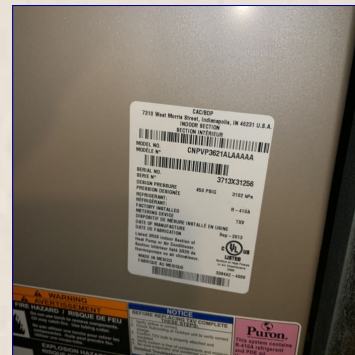
The air conditioner coils data plate.

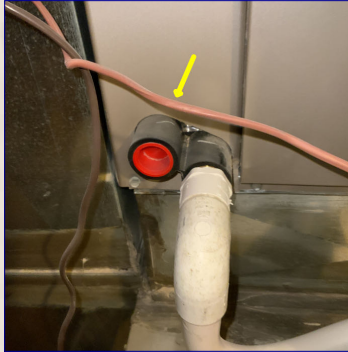
2. Evaporator Coil/Condensate Line

There is no secondary condensate protection installed on the air conditioner evaporator coil drain. This is a common practice, however, we recommend a licensed HVAC contractor install a secondary protection switch to help prevent damage to the furnace in the event that the drain becomes clogged and overflows.
