Home Inspection Report

Inspection Address: 288 Sunny Way

Inspector: Joe Gardino

Inspection Date: 9/15/2022

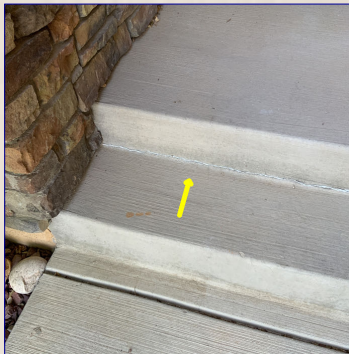
There is a crack at the steps. Recommend a professional contractor seal the crack to help prevent additional damage to the concrete.

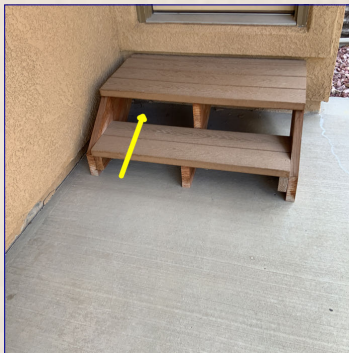
There are open risers on the exterior wood stairs, which is a potential safety concern. Recommend using additional caution in these areas. Install proper risers for added safety.

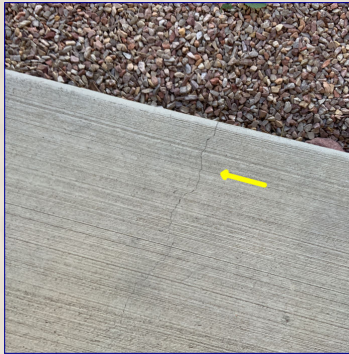
The patio has typical cracks. Recommend a professional contractor seal the cracks to help protect the cement from damage.

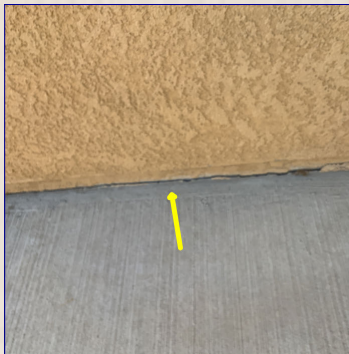
There is a gap between the patio and the house. Recommend sealing the gap between the patio and the house to help prevent water penetration.

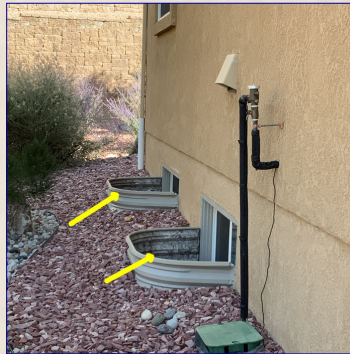
Window well covers are missing in one or more locations. Adding window well covers will help prevent moisture and debris from entering the window wells. In addition, an open window well is a falling hazard. Recommend adding window well covers.

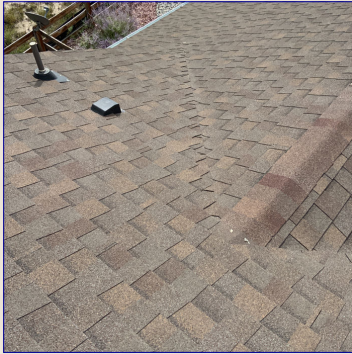
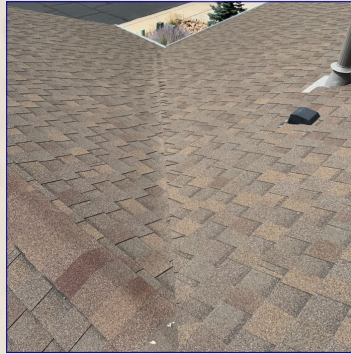
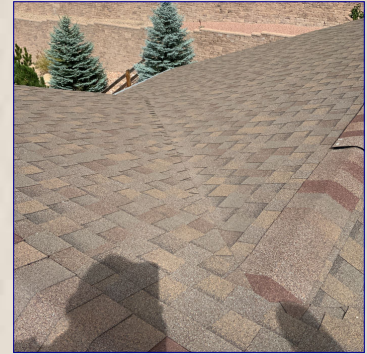
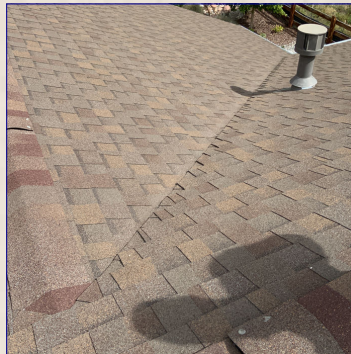
The roof **valleys** inspection is limited to the visual portion of the valleys. There is always the potential for hidden damage in non visible areas. Recommend monitoring and consulting a licensed roofer as needed.

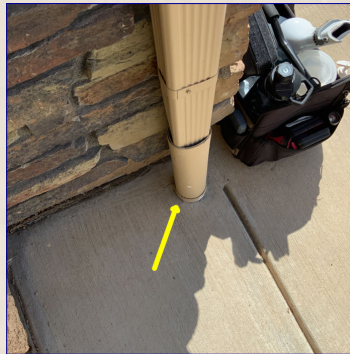
The gutter termination point was not visible. There is always the potential for hidden damage in non visible areas. Recommend monitoring and contacting a licensed contractor as needed.

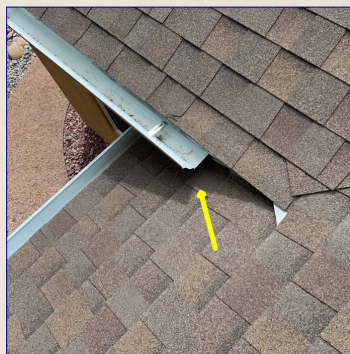
Gutters terminate on roof surfaces, which is a common practice but will concentrate a large amount of water on one location of asphalt shingles. This will allow more wear in one location. Recommend redirecting the water discharge to other gutters or to the ground.

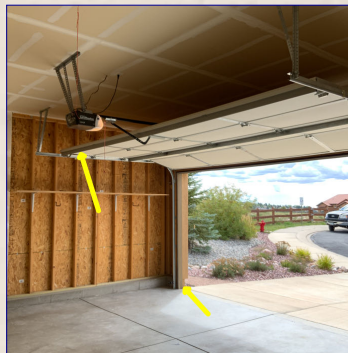
The safety devices on the large garage door cannot be tested due to the door not operating properly. Recommend a licensed contractor repair and re-test safety features on garage door.

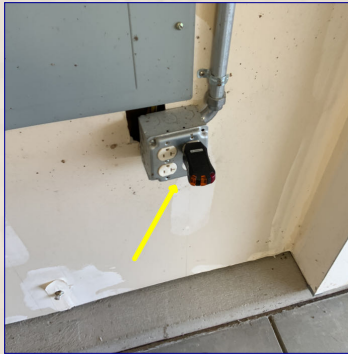
Not all of the electrical outlets are GFCI's installed in the garage, which is a safety concern. Recommend a licensed electrician install GFCI receptacles.

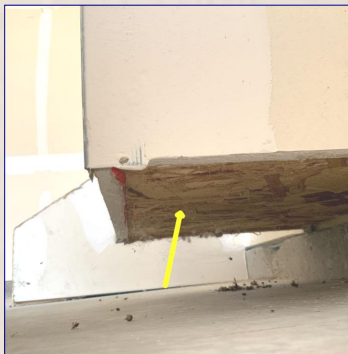
The firewall between the garage and living area is not present in spots - Potential Safety Hazard. Recommend a licensed contractor install a firewall.

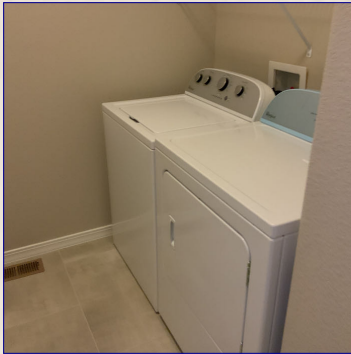
The washer and dryer are excluded from the inspection as they can not be properly tested. Any comments are made for courtesy purposes only.

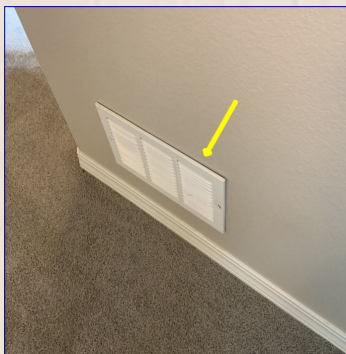
The heating vent has become damaged/detached from the wall. Recommend a professional contractor repair as needed.

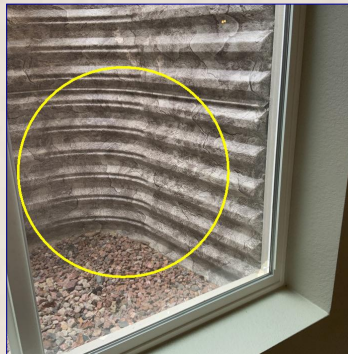
The screen was damaged. Recommend repairing as needed.

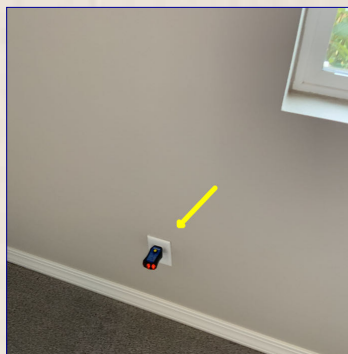
- There are loose receptacles present in the room, which is a potential safety concern. Recommend a licensed electrician repair.

There are loose receptacles present in the room, which is a potential safety concern. Recommend a licensed electrician repair.

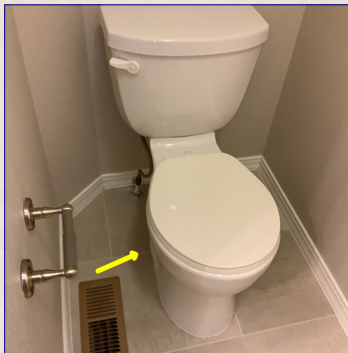
The toilet bowl is loose. Since movement of the toilet will damage the wax ring, recommend replacing the wax ring. While the toilet is removed verify the subfloor is still in good condition. Repair as needed.

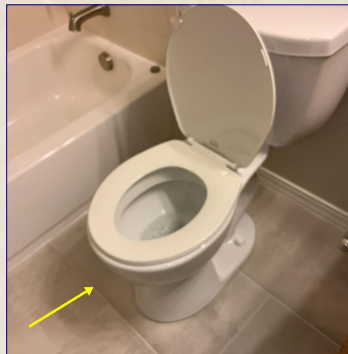
The toilet bowl is loose. Since movement of the toilet will damage the wax ring, recommend replacing the wax ring. While the toilet is removed verify the subfloor is still in good condition. Repair as needed.

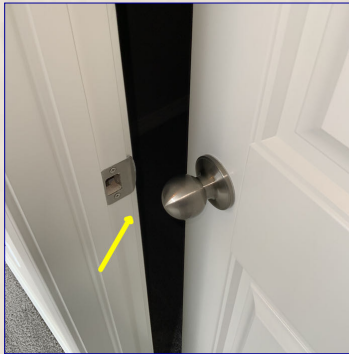
The door does not latch. Recommend repairing as needed.

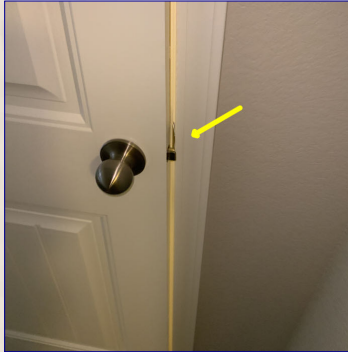
The door does not latch. Recommend repairing as needed.

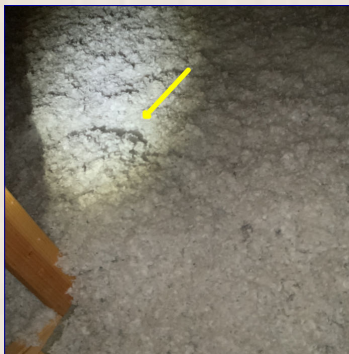
Pests are not part of the home inspection. However, there is evidence of rodents in the attic, which is a safety concern. Recommend a professional exterminator be consulted.

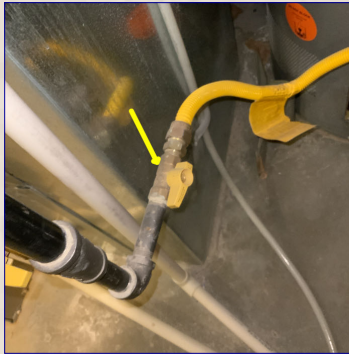
The Water Heater gas shut off valve.

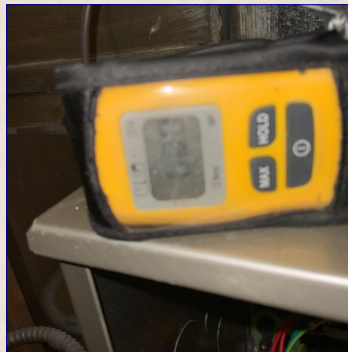
No carbon monoxide was detected. Recommend regular monitoring with proper carbon monoxide detectors. Consult a licensed HVAC technician as needed.

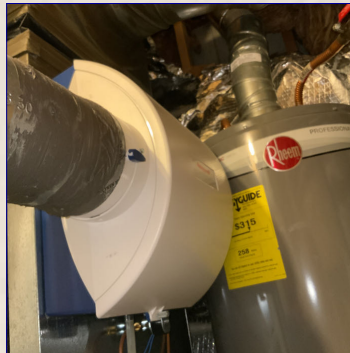
Humidifiers are not part of the home inspection. Recommend normal maintenance per the manufacturers specifications. Consult a licensed HVAC contractor as needed.

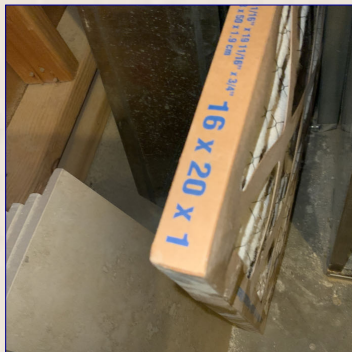
Furnace filter size
